Failure Analysis of a broken Centerlock Disc Brake Socket from the bushing of an Alfine-11-hub

Type of analysis:	Failure analysis	Date:	2018-01-21
Status:	Final report	Task number	SAN-2018-001
part:	bushing, Alfine-11 hub	Manufacturer:	Shimano

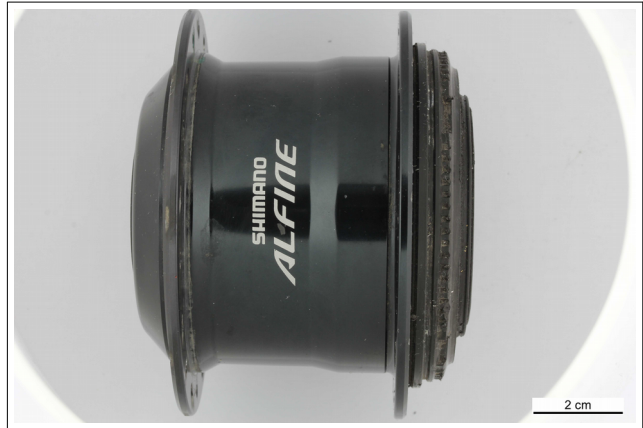
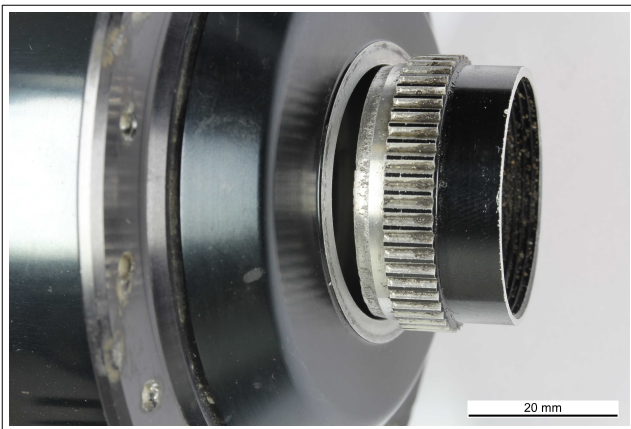
Fig. 1: Bushing of the Alfine-11 hub:
On the left side the socket of
the centerlock disc brake is
missing.

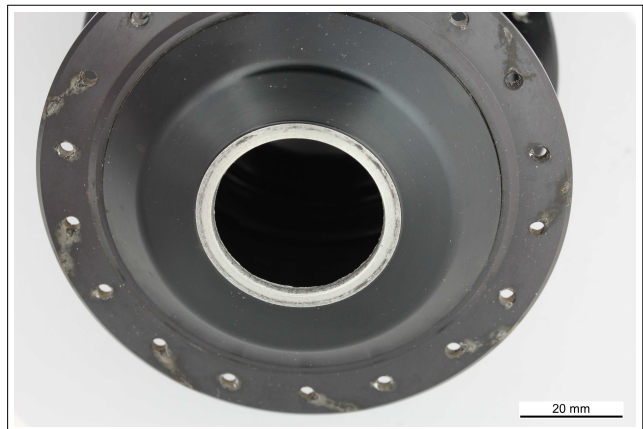
Fig. 2: The side of the bushing
together with the separated
centerlock disc socket

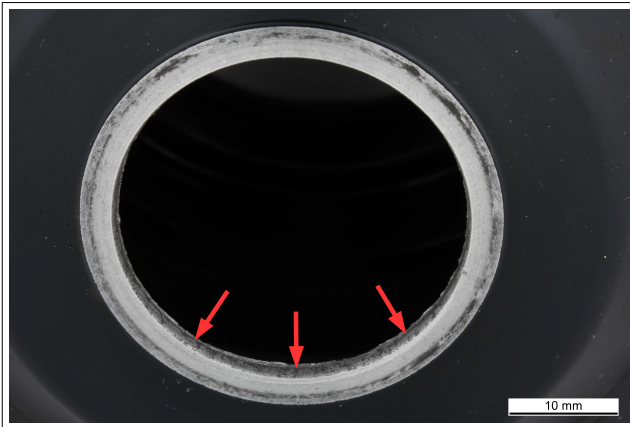
Fig. 3: Front of the bushing where the
centerlock disc socket has
separated

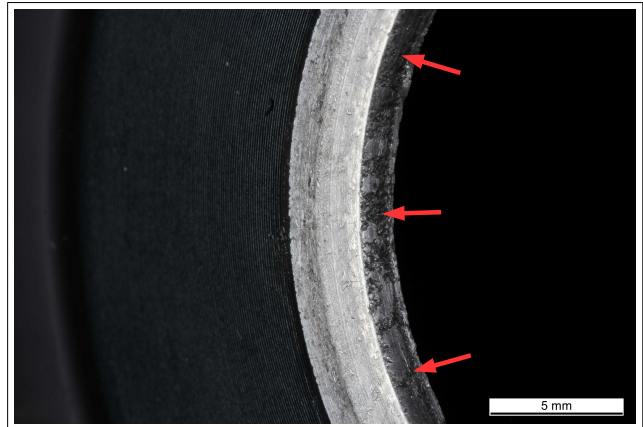
Fig. 4: Magnification of Fig. 3:
The red arrows mark the
fractured area.

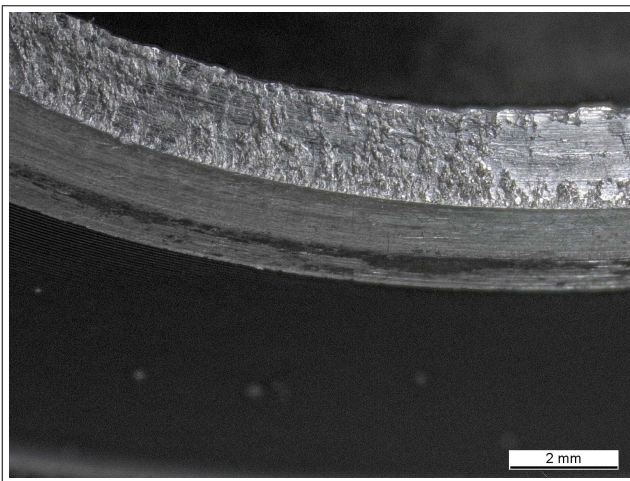
Fig. 5: Further magnification of Fig. 4
The red arrows mark the
fractured area.

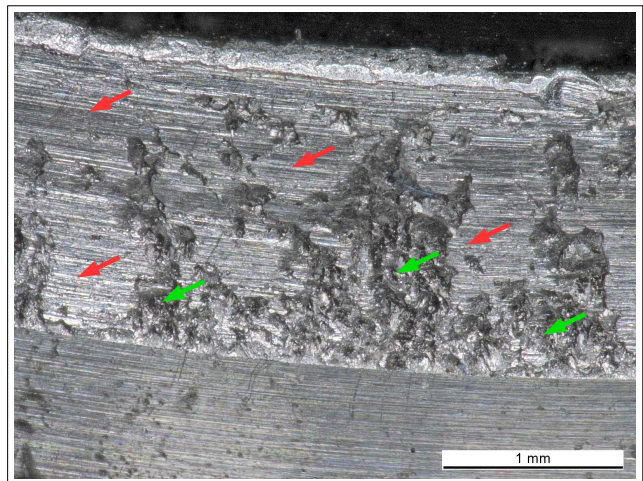
Fig. 6: Further magnification of the
fractured area similar to the
one seen in Fig. 5.

Fig. 7: Detail of the break area:
The green arrows mark
undamaged regions of the
fractured area, whereas the
red arrows mark destroyed
regions of the fractured area.

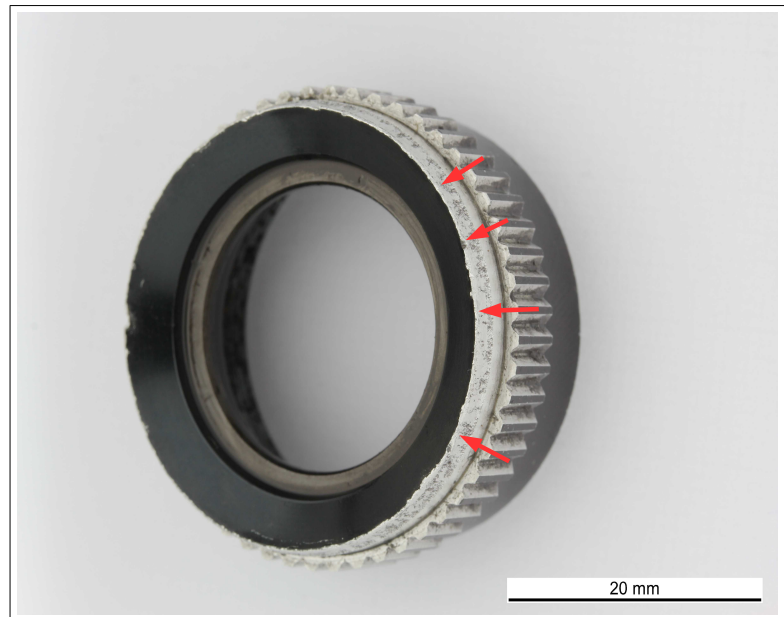
Fig. 8: The fractured area on the separated centerlock socket for the disc brake: The break area is destructed even more heavily on this side in comparison to the bushing side.

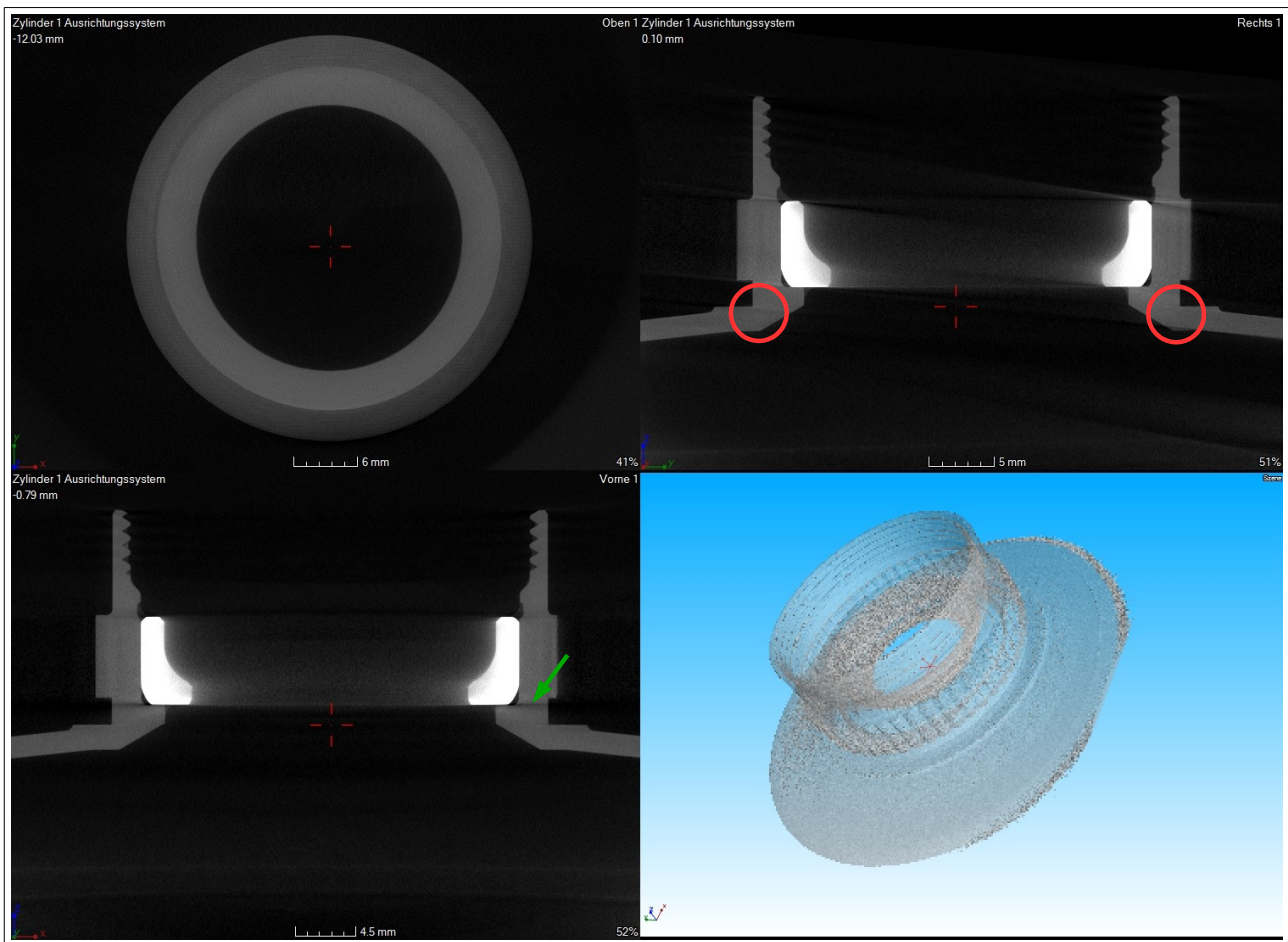
In the context of the failure it seems important that the center lock socket is connected to the bearing without a chamfer on the outside in the region of highest mechanical load. Moreover the transition area between the socket and the bushing has the least wall strength (1,9 mm, Fig. 9+10). It is not comprehensible why Shimano implemented unnecessarily such a predetermined breaking point in a highly safety-relevant component.

Fig. 9: Cutting plane of the faultless part from the 3D-CT for comparison:
The bearing in the press-fit shows clearly visible artefacts (green arrow, see
text for details). The red circles mark the weakest spot of the component.

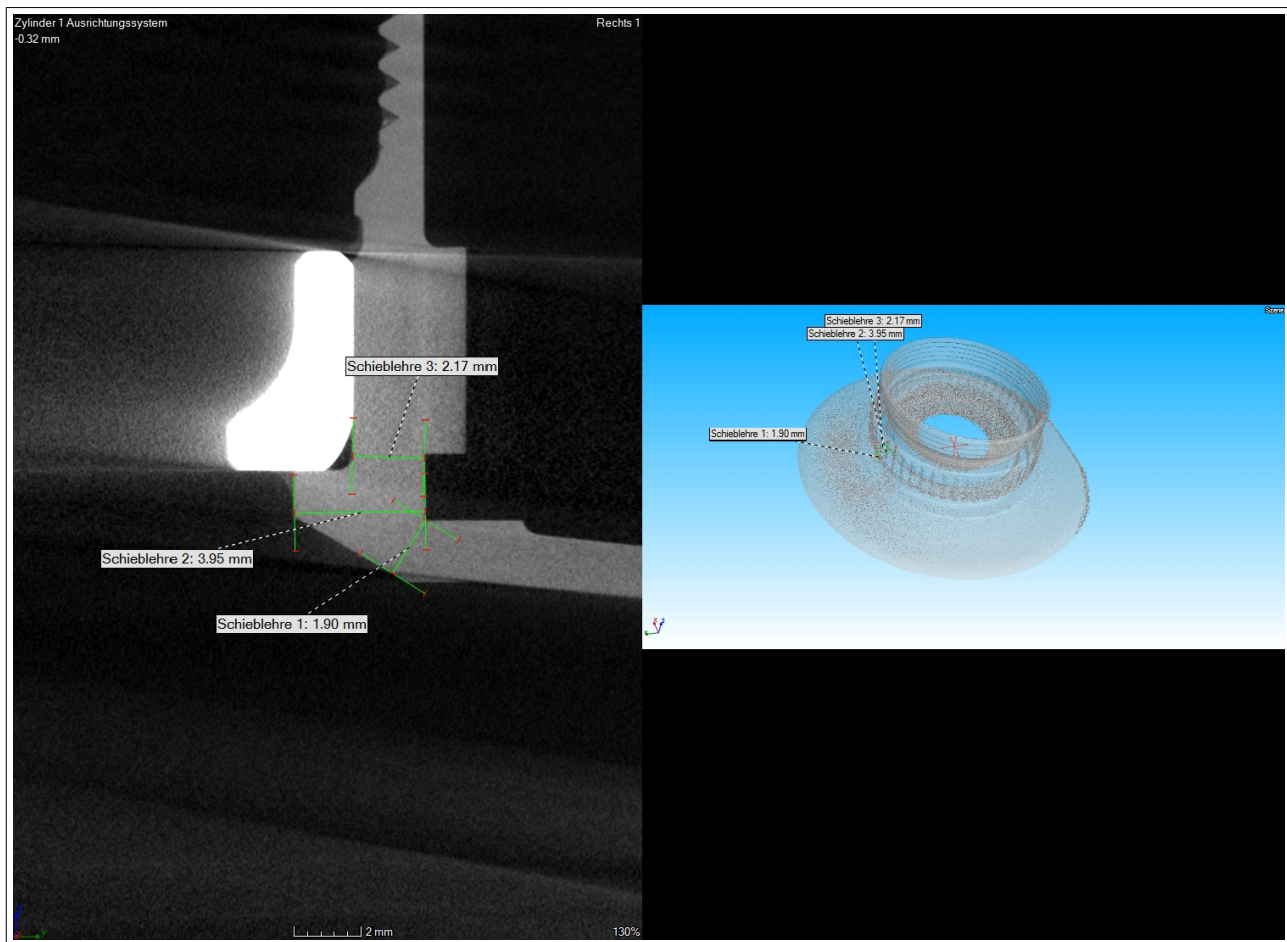
Fig. 10: Cutting plane of the faultless part from the 3D-CT for comparison:
The wall thickness of the bushing was extracted from the CT. In the region of the separated center-lock disc brake socket the minimum wall thickness was less than 2 mm.

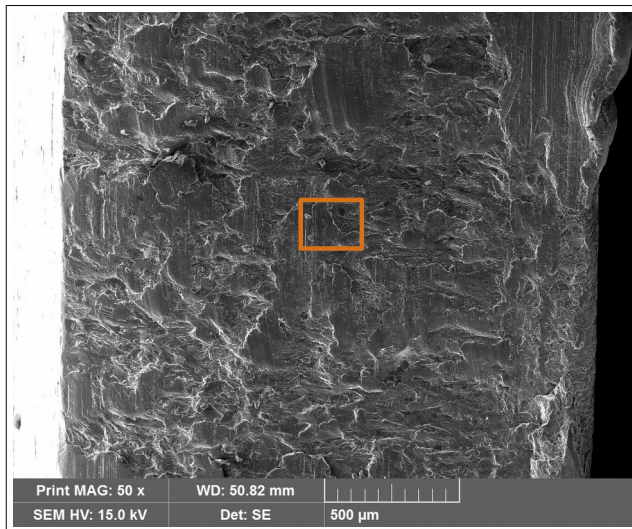
In indentations all over the fractured surface of the remains of the bushing high cycle fatigue lines parallel to the axis of the wheel and perpendicular to the main mechanical load are found indicating that the part did not fail due to a violent, forceful event but due to an ongoing overstress leading to material wear out over a long period of time (two representative regions of the fractured surface see Fig. 11-16).

Fig. 11: Fractured surface where the brake-disc socket separated from the bushing:
left side = outer side
the colored rectangle indicates the magnified region in Fig. 12

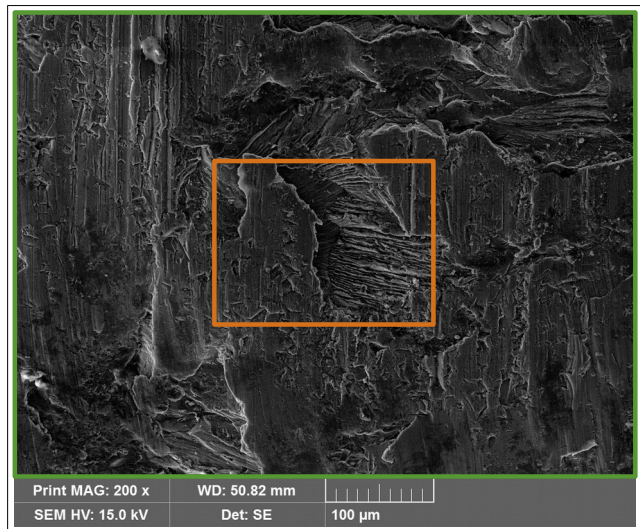
Fig. 12: Magnification from Fig. 11:
At this magnification typical lines perpendicular to the load direction become visible (compare with Fig. 13)

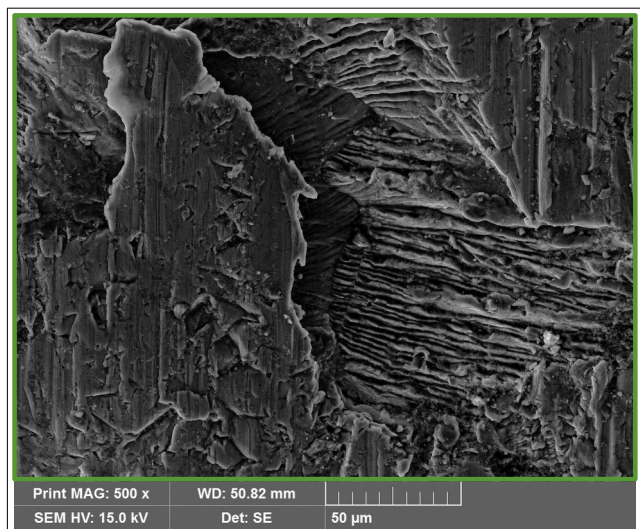
Fig. 13: Magnification from Fig. 12:
At this magnification the typical high cycle fatigue lines are clearly visible.

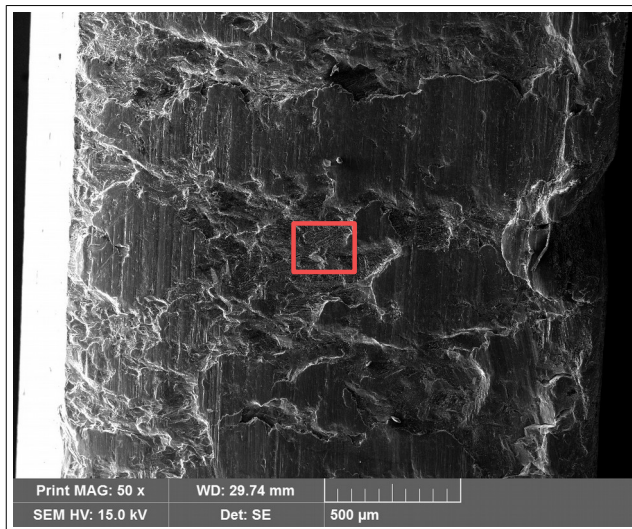
Fig. 14: A second fractured surface distant from the first on in Fig. 11:
left side = outer side
the colored rectangle indicates the magnified region in Fig. 15

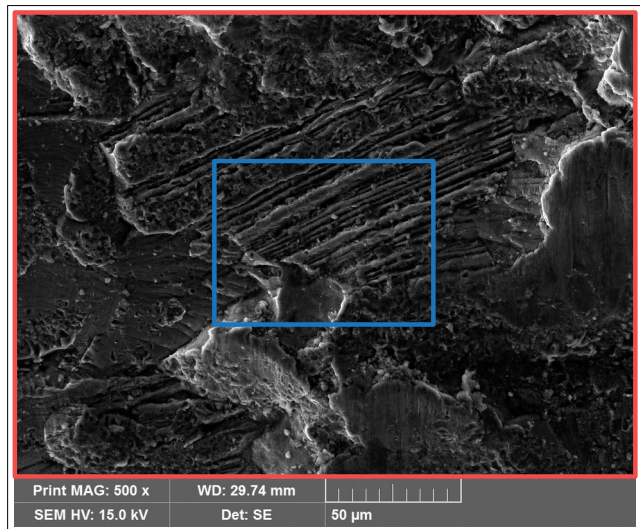
Fig. 15: Magnification from Fig. 14:
At this magnification typical lines perpendicular to the load direction become visible (compare with Fig. 16)

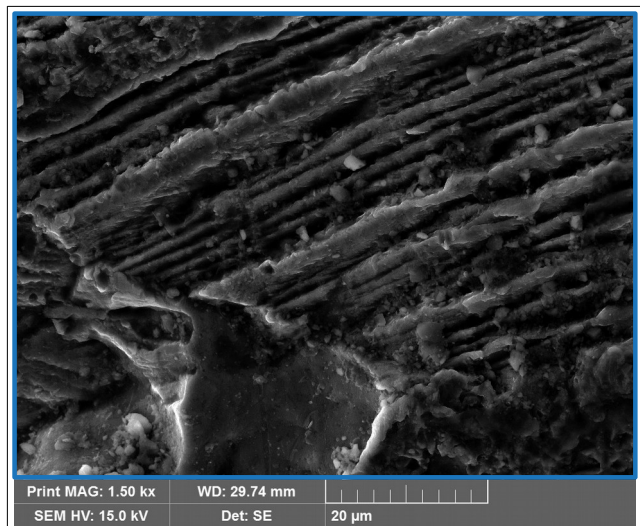
Fig. 16: Magnification from Fig. 15:
At this magnification the typical high cycle fatigue lines are clearly visible.
